General Service Bulletin

Condensate Trap Tubing Interference in Horizontal Left/Right Applications

ORDER No: FURN-SVB055A-EN

DATE: March 7, 2016

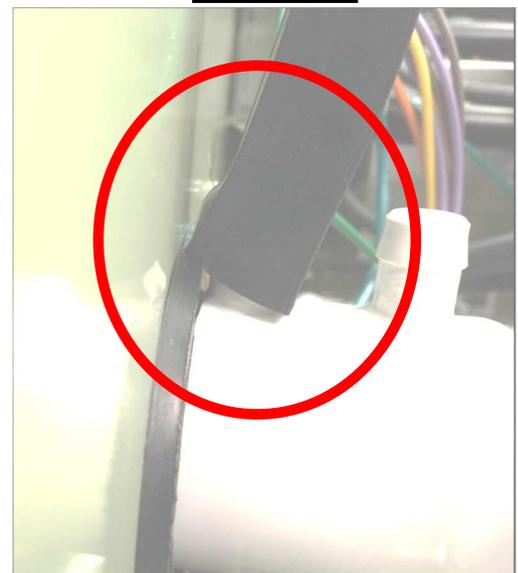
Figure 1

This is a “mandatory” rework for installed furnaces in horizontal left/right applications only. Interference between the horizontal condensate grommet and the condensate trap’s lower connection may not allow the tubing to be fully seated on the “C” width furnace models listed above. (See Figure 1) The action described in this bulletin is not being taken to address a safety concern.

It has been determined that the horizontal condensate grommet creates interference with the rain gutter tubing and doesn’t allow the tubing to be fully seated on the condensate trap’s lower port when the “C” width (21.0”) furnace is installed in the horizontal left/right position. Due to the tubing not being fully seated, there is potential for condensate to leak at this connection.

An improved condensate grommet is being designed to eliminate the interference between the grommet and condensate trap. In the meantime, the current condensate grommet will need to be modified before installation. Affected furnaces that have been installed will need to be re-worked following the corrective actions listed on page 2.
